Restoration of Keweenaw Bay Indian Community's Sand Point Sloughs increases cultural and ecological functionality

Significant progress made but additional restoration could counter-balance losses

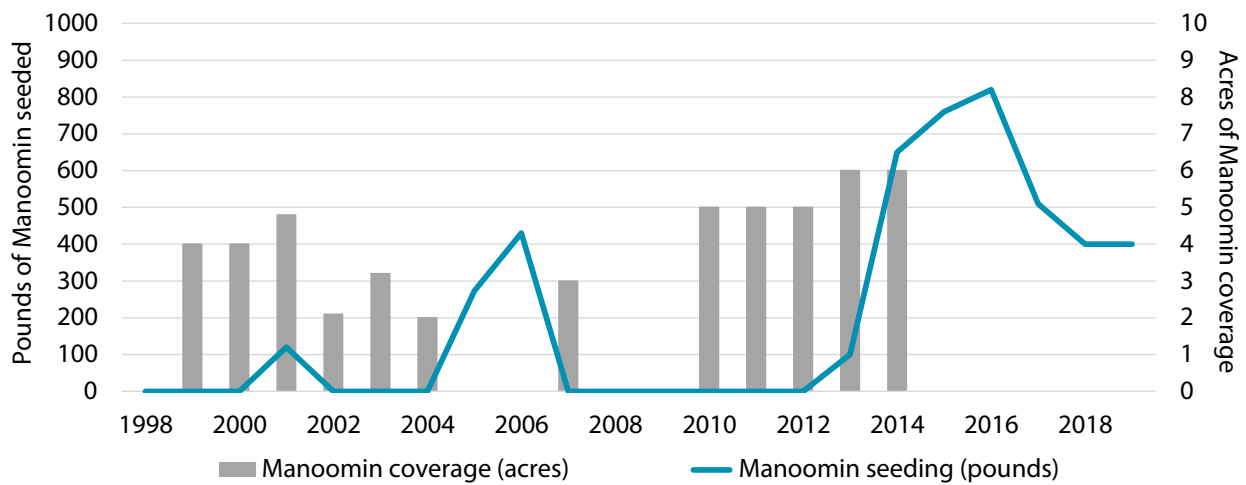
Manoomin seeding and acres of Manoomin coverage at the Sand Point Sloughs, 1999 to 2019 (data were not collected before 1999, and Manoomin coverage data were not recorded after 2014).

Sand Point Sloughs are a KBIC Tribal Trust property, wholly owned by KBIC and located entirely within KBIC L'Anse Reservation boundaries. KBIC took over management of the sloughs in the early 1990s, and shortly after began efforts to reintroduce Manoomin. Between 1991 and 1997, KBIC seeded nearly 1,800 pounds of Manoomin across 8 acres of Sand Point Sloughs. By 1999, Manoomin density was sufficient for KBIC to engage in the tradition of ricing. Between 1999 and 2002, community members harvested an estimated 60 to 150 pounds per year (Ravindran et al., 2014). Since 2013, KBIC has seeded annually at Sand Point Sloughs. KBIC continues to tend to this site in an effort to keep Manoomin teachings and traditions vital. However, since 2002, community members have not been able to harvest Manoomin at Sand Point Sloughs due to decreased abundance of Manoomin related to regional hydrologic conditions.

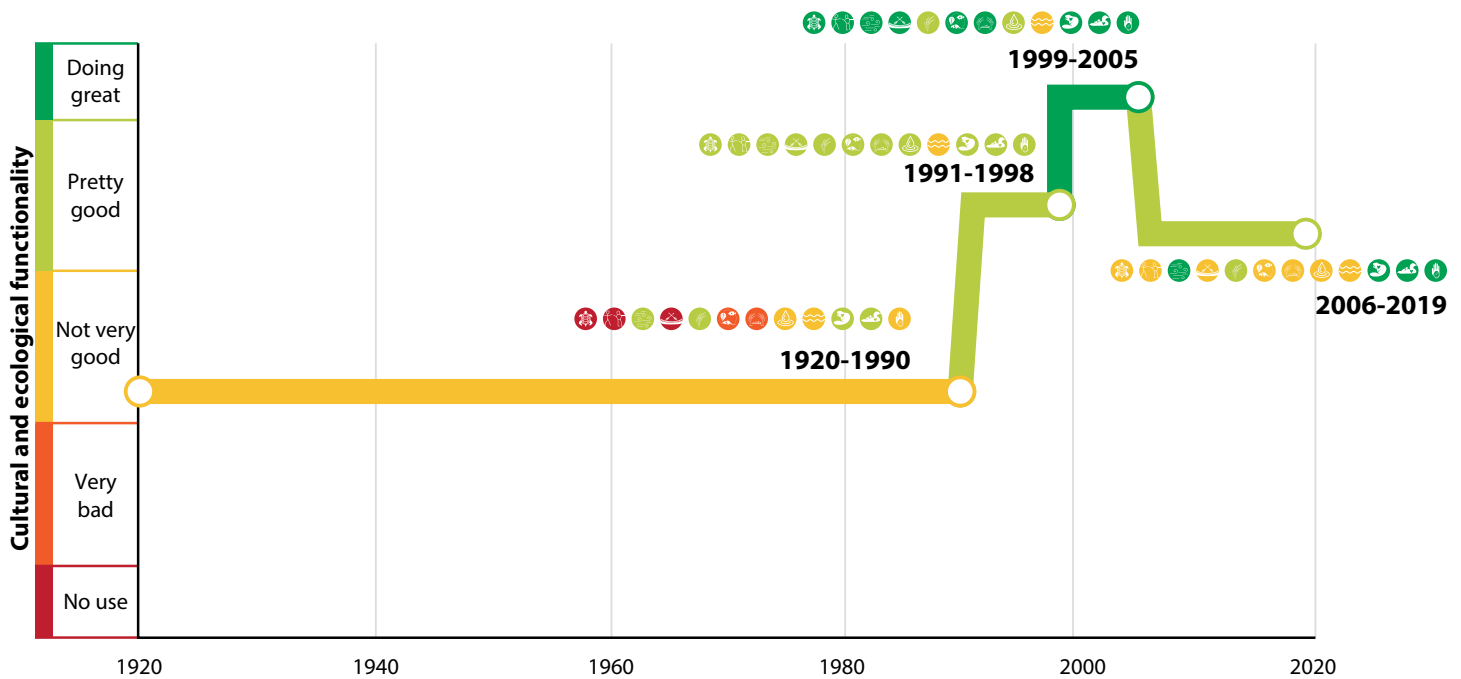
Cultural and ecological characterization at Sand Point Sloughs

The cultural and ecological functionality provided by the Manoomin and its associated habitat at Sand Point Sloughs varied over time, both in aggregate and for individual metrics.

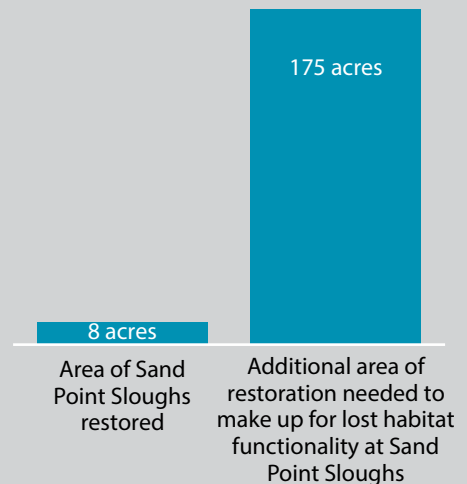
Based on the characterization of the degree of cultural and ecological function over the four time periods, a Habitat Equivalency Analysis demonstrates the additional equivalent units of restoration needed to counter-balance the severity and timespan of degradation. Given the success of restoration on 8 acres of Sand Point Sloughs, 175 acres of similar Manoomin restoration is needed to counter-balance the lost habitat functionality that has occurred over time. In other words, 22 equivalent restoration efforts at Sand Point Sloughs (from 1991 to 2019) are needed to counter-balance lost cultural and ecological habitat functionality (from 1920 to 1990).
